Improving Forensic and Analytical Capabilities with the FARO Laser Scanner

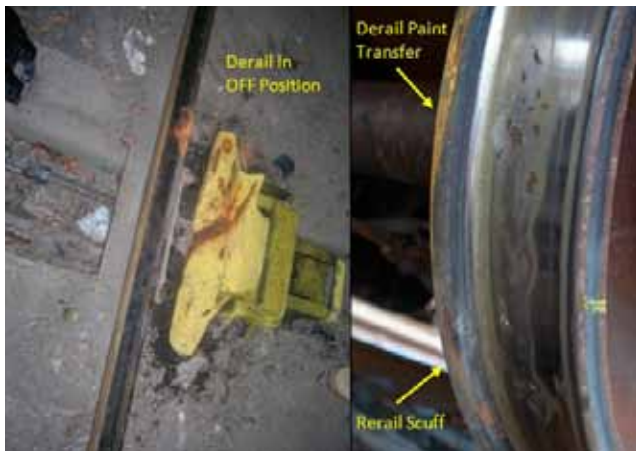
The main component of a derail is called the *shoe*, which is a 24-inch long metal casting that rests on top of the rail. The shoe is shaped to redirect railcar wheels off the rail to prevent runaway railcars from reaching unauthorized track.
