FARO® Laser Scanner Data Instrumental In Near-Collision Case Involving Sprayer And Speeding Car

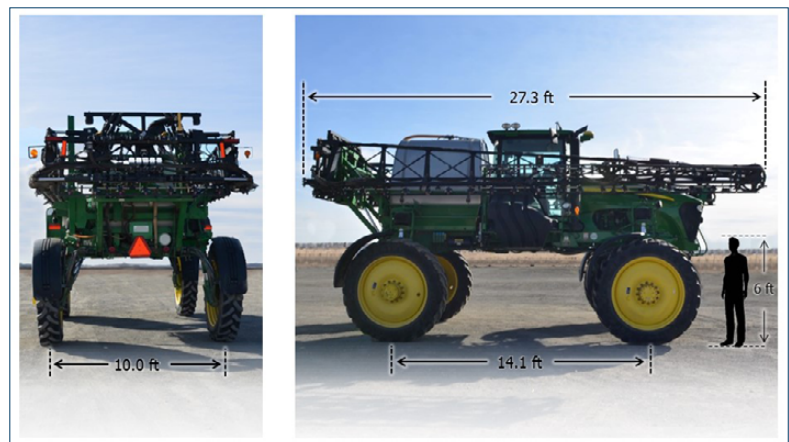
Photographs and overall dimensions of the sprayer.

An important issue in the case was the configuration of the sprayer, which had a large chemical tank located behind the driver's cab, thus preventing a direct view through the rear window. The sprayer, to compensate for its limitation, had been fitted with three adjustable, exterior mirrors to provide the operator an extended field-of-view to the rear.

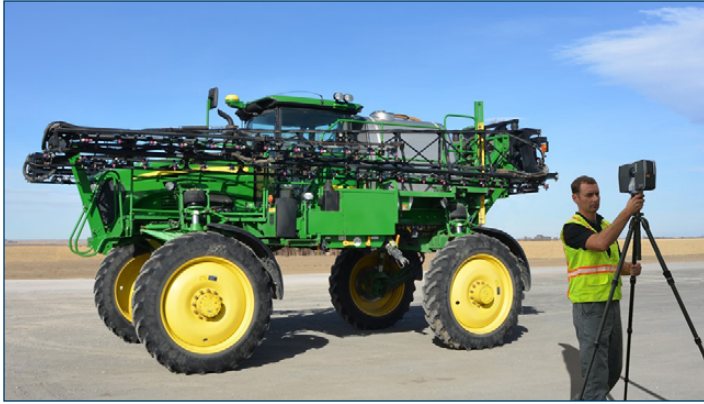
Mark S. Erickson, P.E., sets up the FARO 3D X 130 to scan the farm sprayer that was involved in an incident.

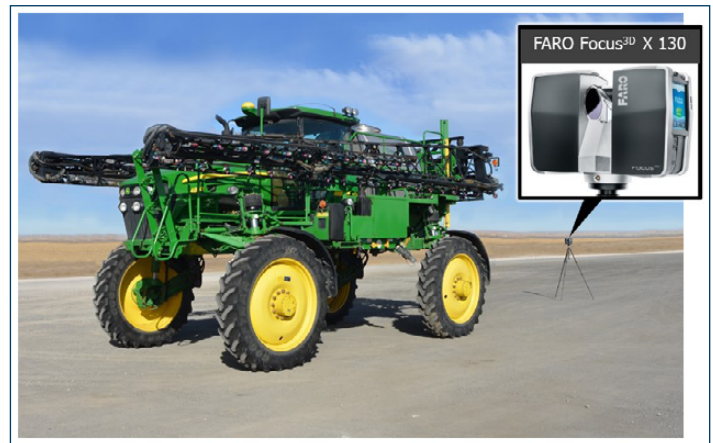
Erickson used the FARO 3D X 130 Laser Scanner to capture an accurate 3D model that could be used to digitally determine the sprayer's field-of-view to the rear.

After the crash, the sprayer was transported to a parking lot so it was available for Erickson's investigation. Erickson photographed the sprayer and took four laser scans—one from the front, one scan on either side, and one from the sprayer's rear. These scans provided an accurate 3D model of the entire vehicle, which could be used to obtain critical measurements. Erickson said that the FARO Laser Scanner allows him to be thorough and collect millions of detailed points of information, any of which may become useful as the investigation progresses.

The laser scan data included the operator seat position, mirror locations (fore-aft and angular adjustment settings), the position and configuration of the sprayer boom arm, and other vehicle components that would have been visible in the mirrors. According to Erickson, the measurement data showed there was nothing the sprayer's operator could have done to prevent the car's crash. "He (the sprayer operator) could not have seen or known that the car was approaching at its given speed," Erickson explained.

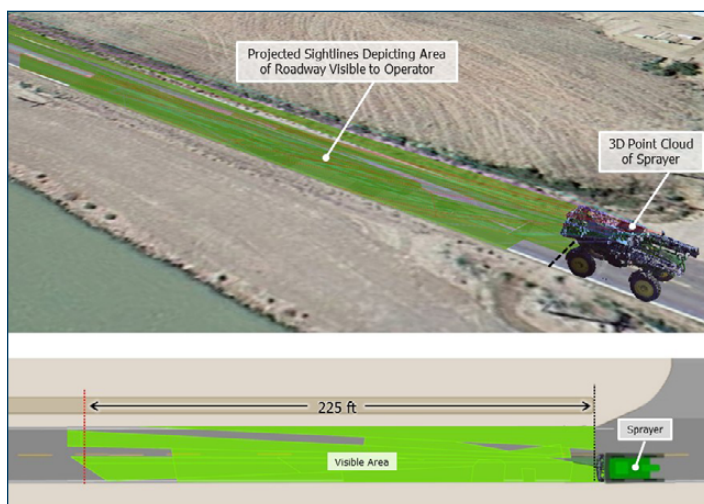
A 3D model of the sprayer, as captured with the FARO Laser Scanner, is digitally inserted into the scene of the crash to show the driver's field-of-view.

Once Erickson created a comprehensive point cloud model of the sprayer, he used CAD software to project the sprayer operator's sightlines (available with the sprayer's exterior mirrors) onto the roadway surface. This data allowed a precise field-of-view to be established.

The point clouds showed all of the areas that the sprayer's driver could have seen to his rear if he was using the equipment's mirrors. "Some areas might have been obstructed by the sprayer's large booms and chemical tank," Erickson explained. "The line of sight goes back about 225 feet, which is far enough that the car would have been visible if it was going the speed limit."

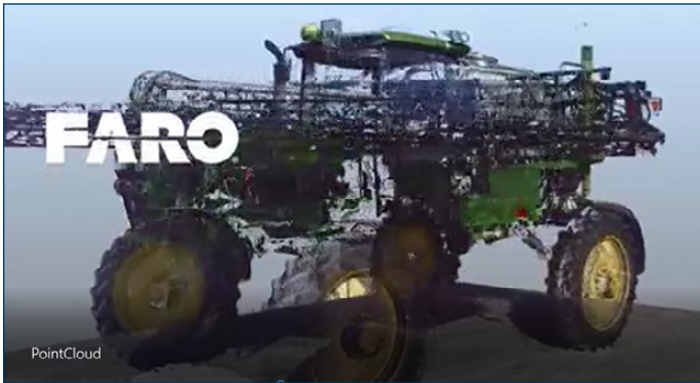
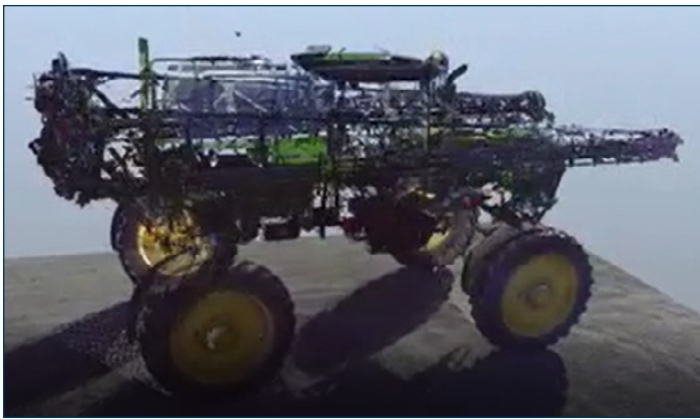
Views of the point cloud of the sprayer, scanned with the FARO^{3D} X 130 Laser Scanner
