Cincinnati's Iconic Music Hall Receives a Laser-Scan Close-Up

FARO® Laser Scanners Come to the Rescue of the Fabled Cincinnati Music Hall

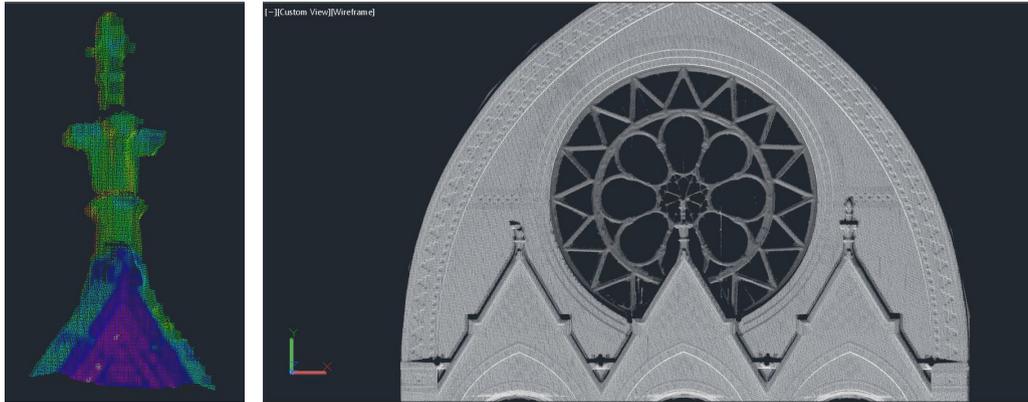
The FARO Focus⁵ 350 Laser Scanner captured Cincinnati Music Hall's exterior in detail to facilitate reproduction of missing architectural decorative elements.

Justice arranged for FARO professionals to not only scan the decorative elements, but also the entire structure. The incredibly precise scan—accurate to within one millimeter—would serve as an essential as-built digitized document for any future design need.

in rainy conditions, which happened to be the weather on the day of the scan. The scanner also delivers real time, on-site registration, seamlessly stitching-together the 20 to 25 scans required to digitally capture all exterior detail. On-site registration is a huge time saver, according to Justice.
